**Lyons Avenue/Dockweiler Road Extension Project
Draft Environmental Impact Report**

**Appendix F
Geologic and Geotechnical Report**

GEOLOGIC AND GEOTECHNICAL REPORT

EIR-Level Review of Road Alignments for

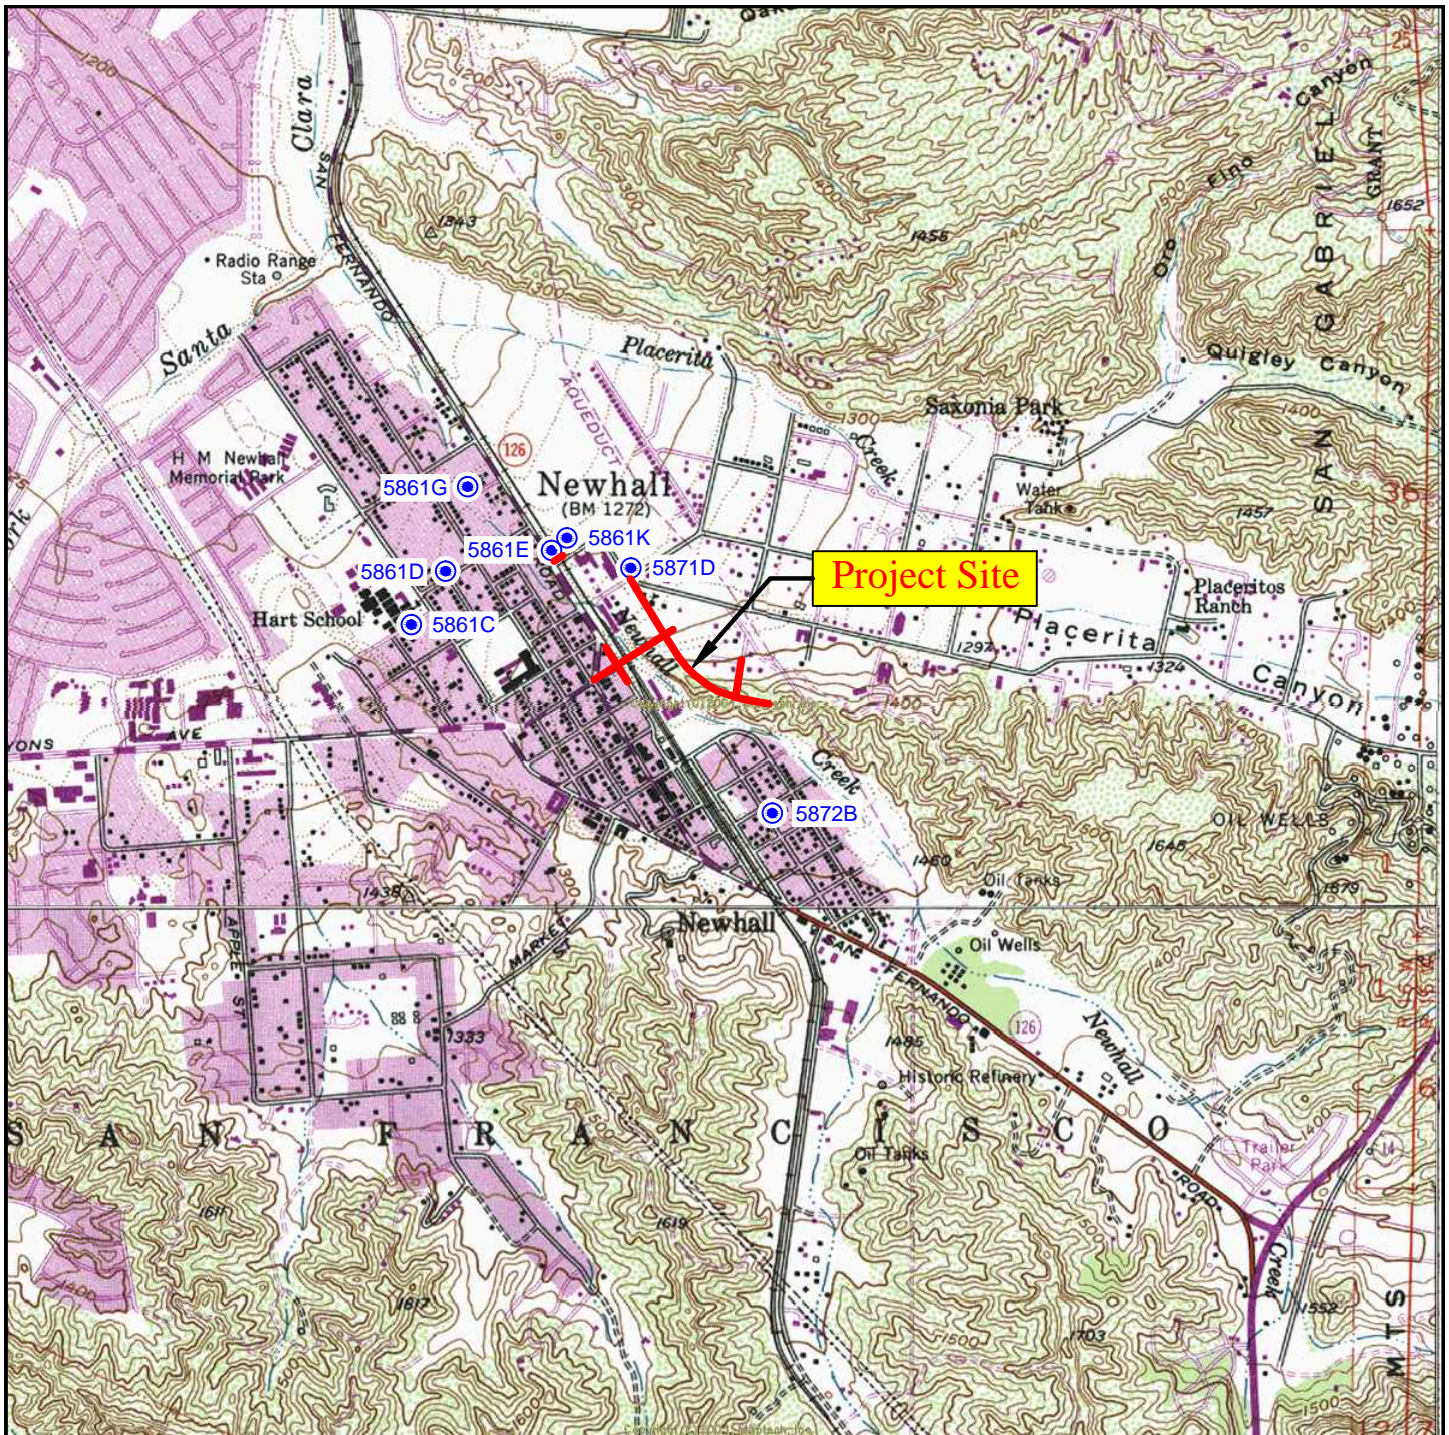
Review of LACFCD records indicates that water wells have been drilled in the vicinity of the proposed road alignments (see Water Well Location Map, **Figure 2**). If one of these water well is within the proposed road alignment, or if a water well is encountered during future construction operations at the site, the location should be surveyed and the potential impacts to well conditions should be evaluated.

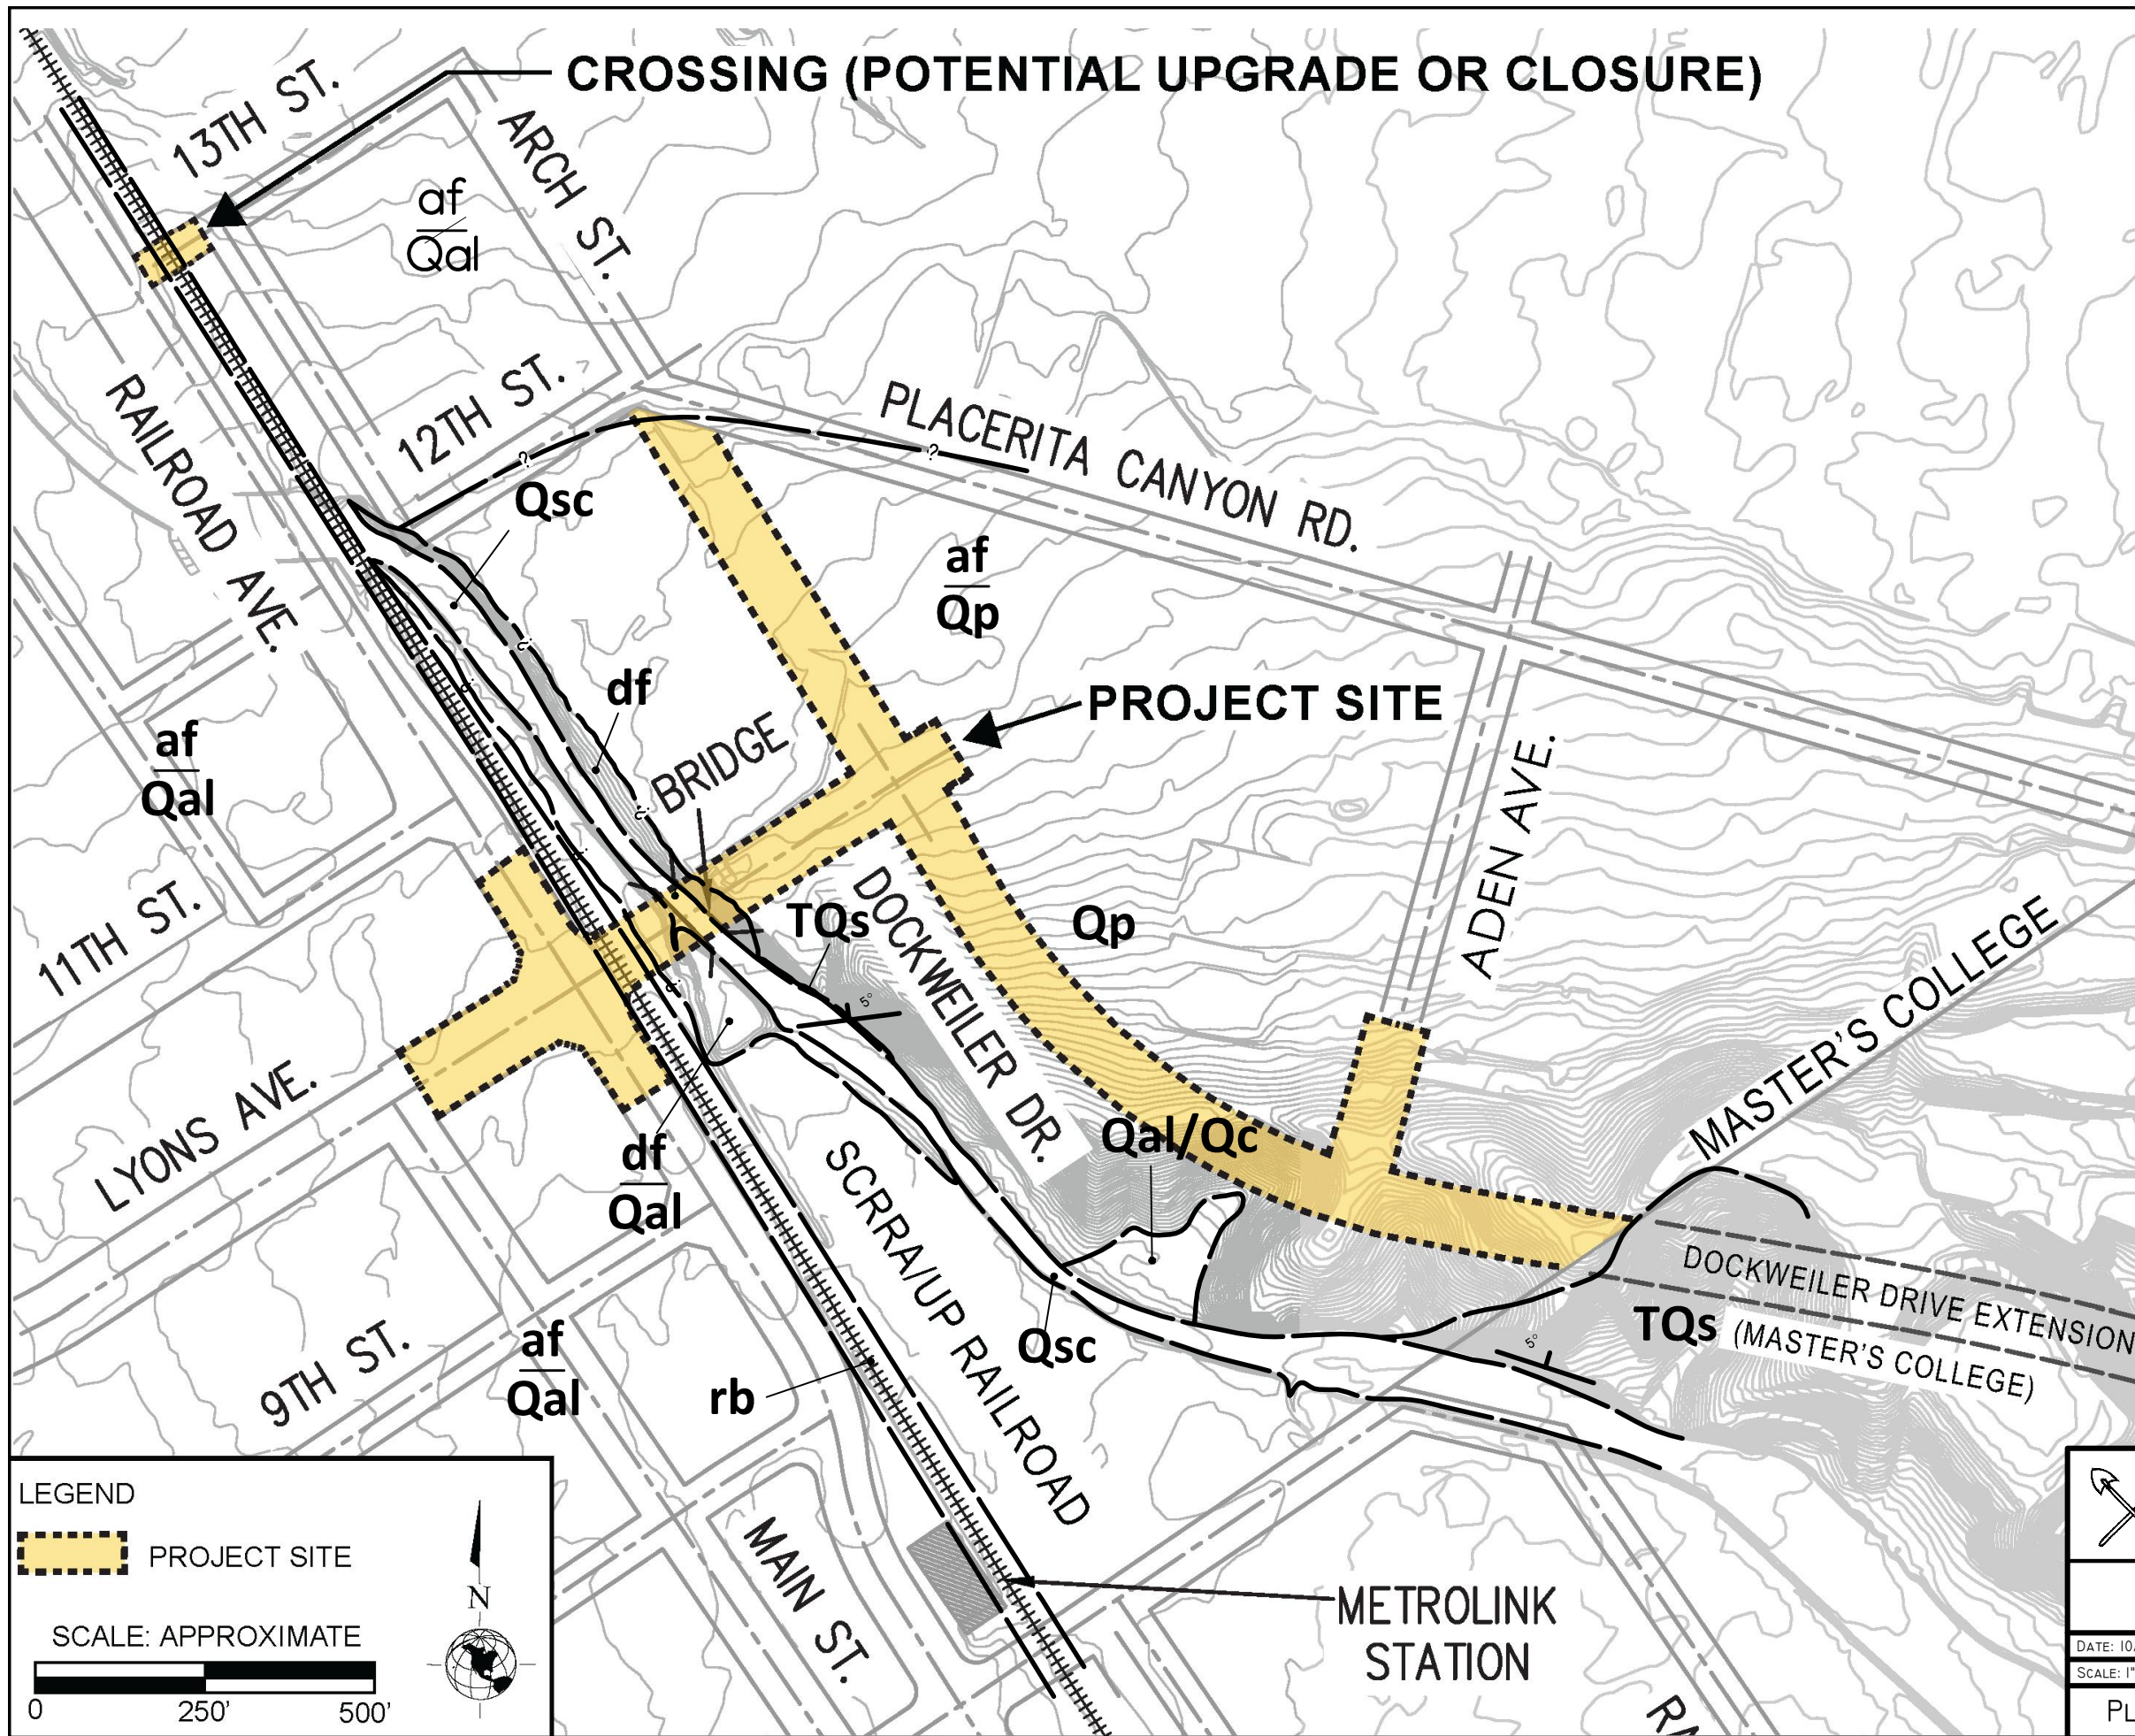
The majority of the project site is underlain by bedrock materials that are not susceptible to liquefaction. The alluvial soils present the site (see Geologic Map, **Plate I**) are not designated on the State of California Seismic Hazard Zone Map for the Newhall Quadrangle as a zone in which investigation of potentially liquefiable materials is required. The depth to historic high ground water at the site is greater than 50 ft. Based on the preceding factors, the potential for liquefaction and associated seismic settlements and lateral spreading is therefore considered very low.
