Biological Resources Technical Report

Santa Clarita Commerce Center Project

MAY 2023

DUDEK

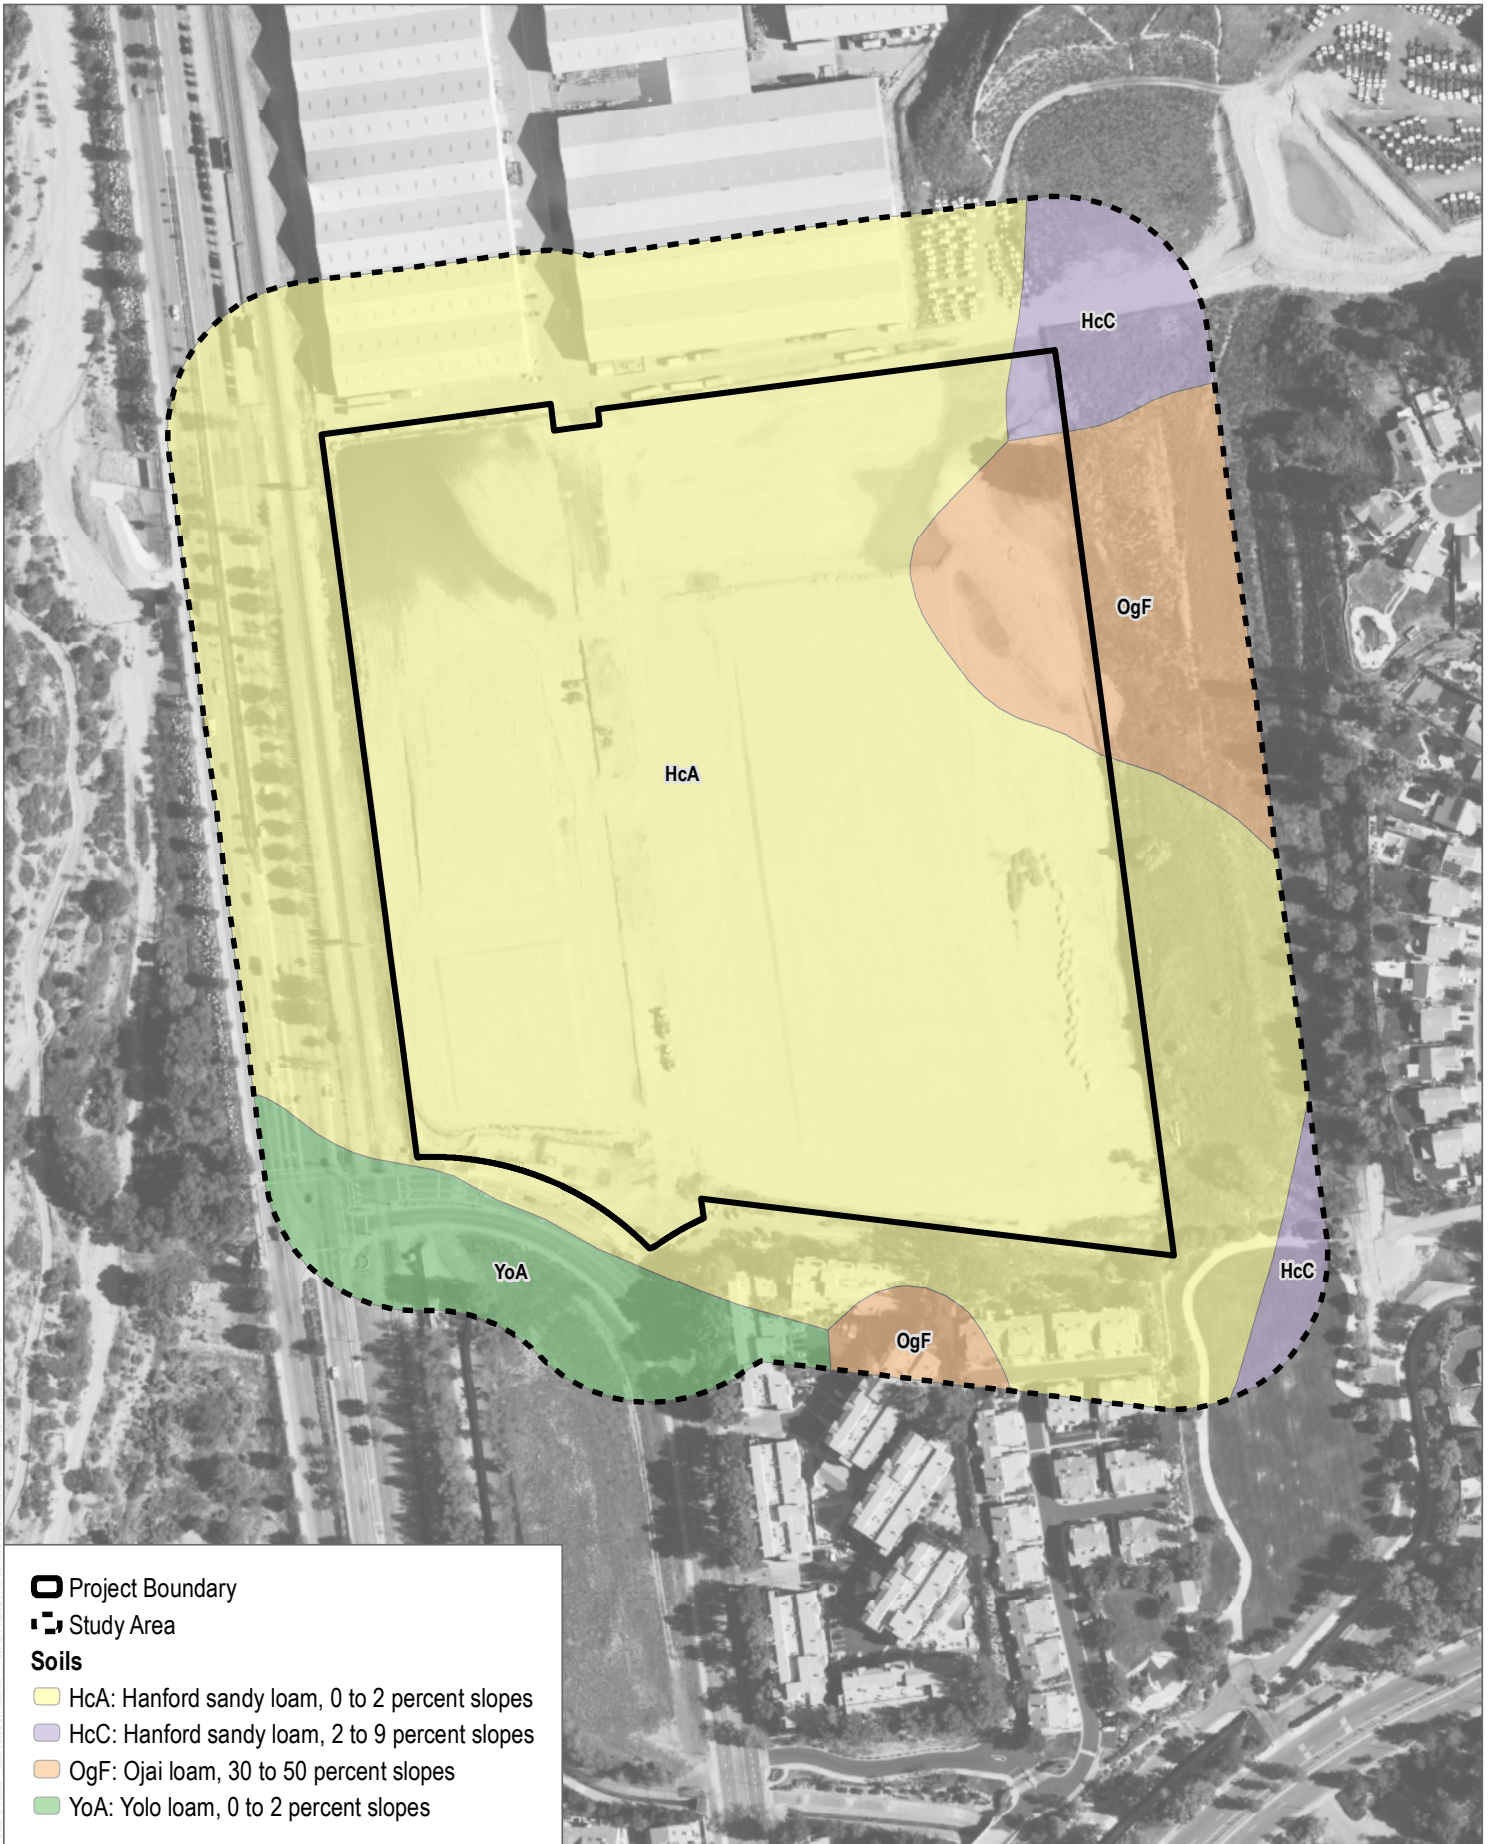
FIGURE 2

Soils

- **Hanford Series.** The Hanford series consist of very deep, well drained soils that formed in moderately coarse textured alluvium dominantly from granite. Hanford soils are fine sandy loam and found on stream bottoms, floodplains and alluvial fans. Vegetation in uncultivated and undeveloped areas is mainly annual grasses and associated herbaceous plants.

- **Ojai Series.** The Ojai series consists of very deep, well drained soils that formed in alluvium derived from material weathering from mostly sandstone or related sedimentary rocks. Ojai fine-loamy soils are found on alluvial fans and terraces. Native vegetation is oak, grasses, forbs, sagebrush and various shrubs.

- **Yolo Series.** The Yolo series consists of very deep, well drained soils that formed in alluvium from mixed rocks. Yolo soils are fine-silty and found on alluvial fans and flood plains. Vegetation in uncultivated and undeveloped areas is annual grasses, forbs, and some scattered oak (*Quercus* spp.).

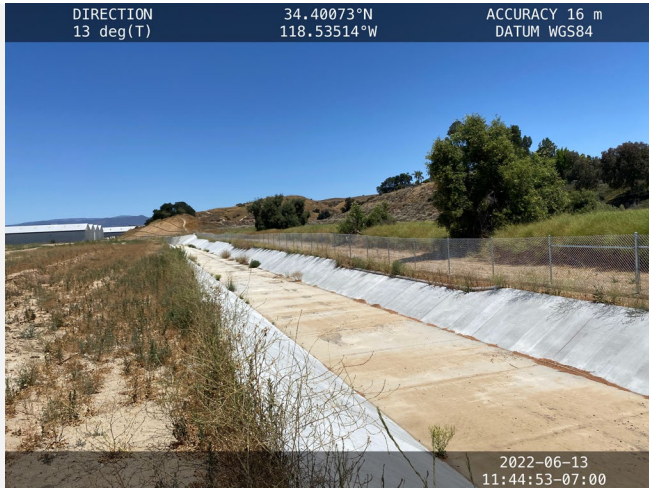
Photo 5. Representative photo of the stormwater channel previously constructed along the eastern boundary of the Project site.

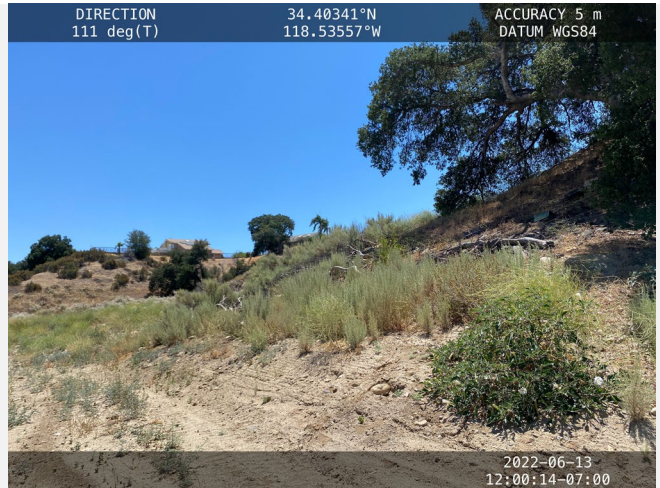
Photo 6. Representative photo of the coast live oak within the Project site.

A Protected Tree Report was prepared for the Project by a Dudek ISA-Certified Arborist (Appendix B). A total of seven non-protected trees (six blue elderberry and one Goodding’s willow) and a protected coast live oak tree and a protected valley oak tree were inventoried within or immediately adjacent to the Project area as part of the preparation of the Protected Tree Report). In total, eight trees are located on-site (Tree Nos. 1 through 8) and one (Tree No. 9) is located on private property adjacent to the site. Of the eight trees found on site, only the coast live oak, Tree No. 2, meets the City’s definition of a protected tree. The single off-site valley oak tree, Tree No. 9, located on the adjacent private property, meets the City’s definition of a protected tree. Appendix B presents the details of the health of the tree, as well as the location of the trees. The coast live oak is the only protected tree whose trunk is within the Project boundaries.

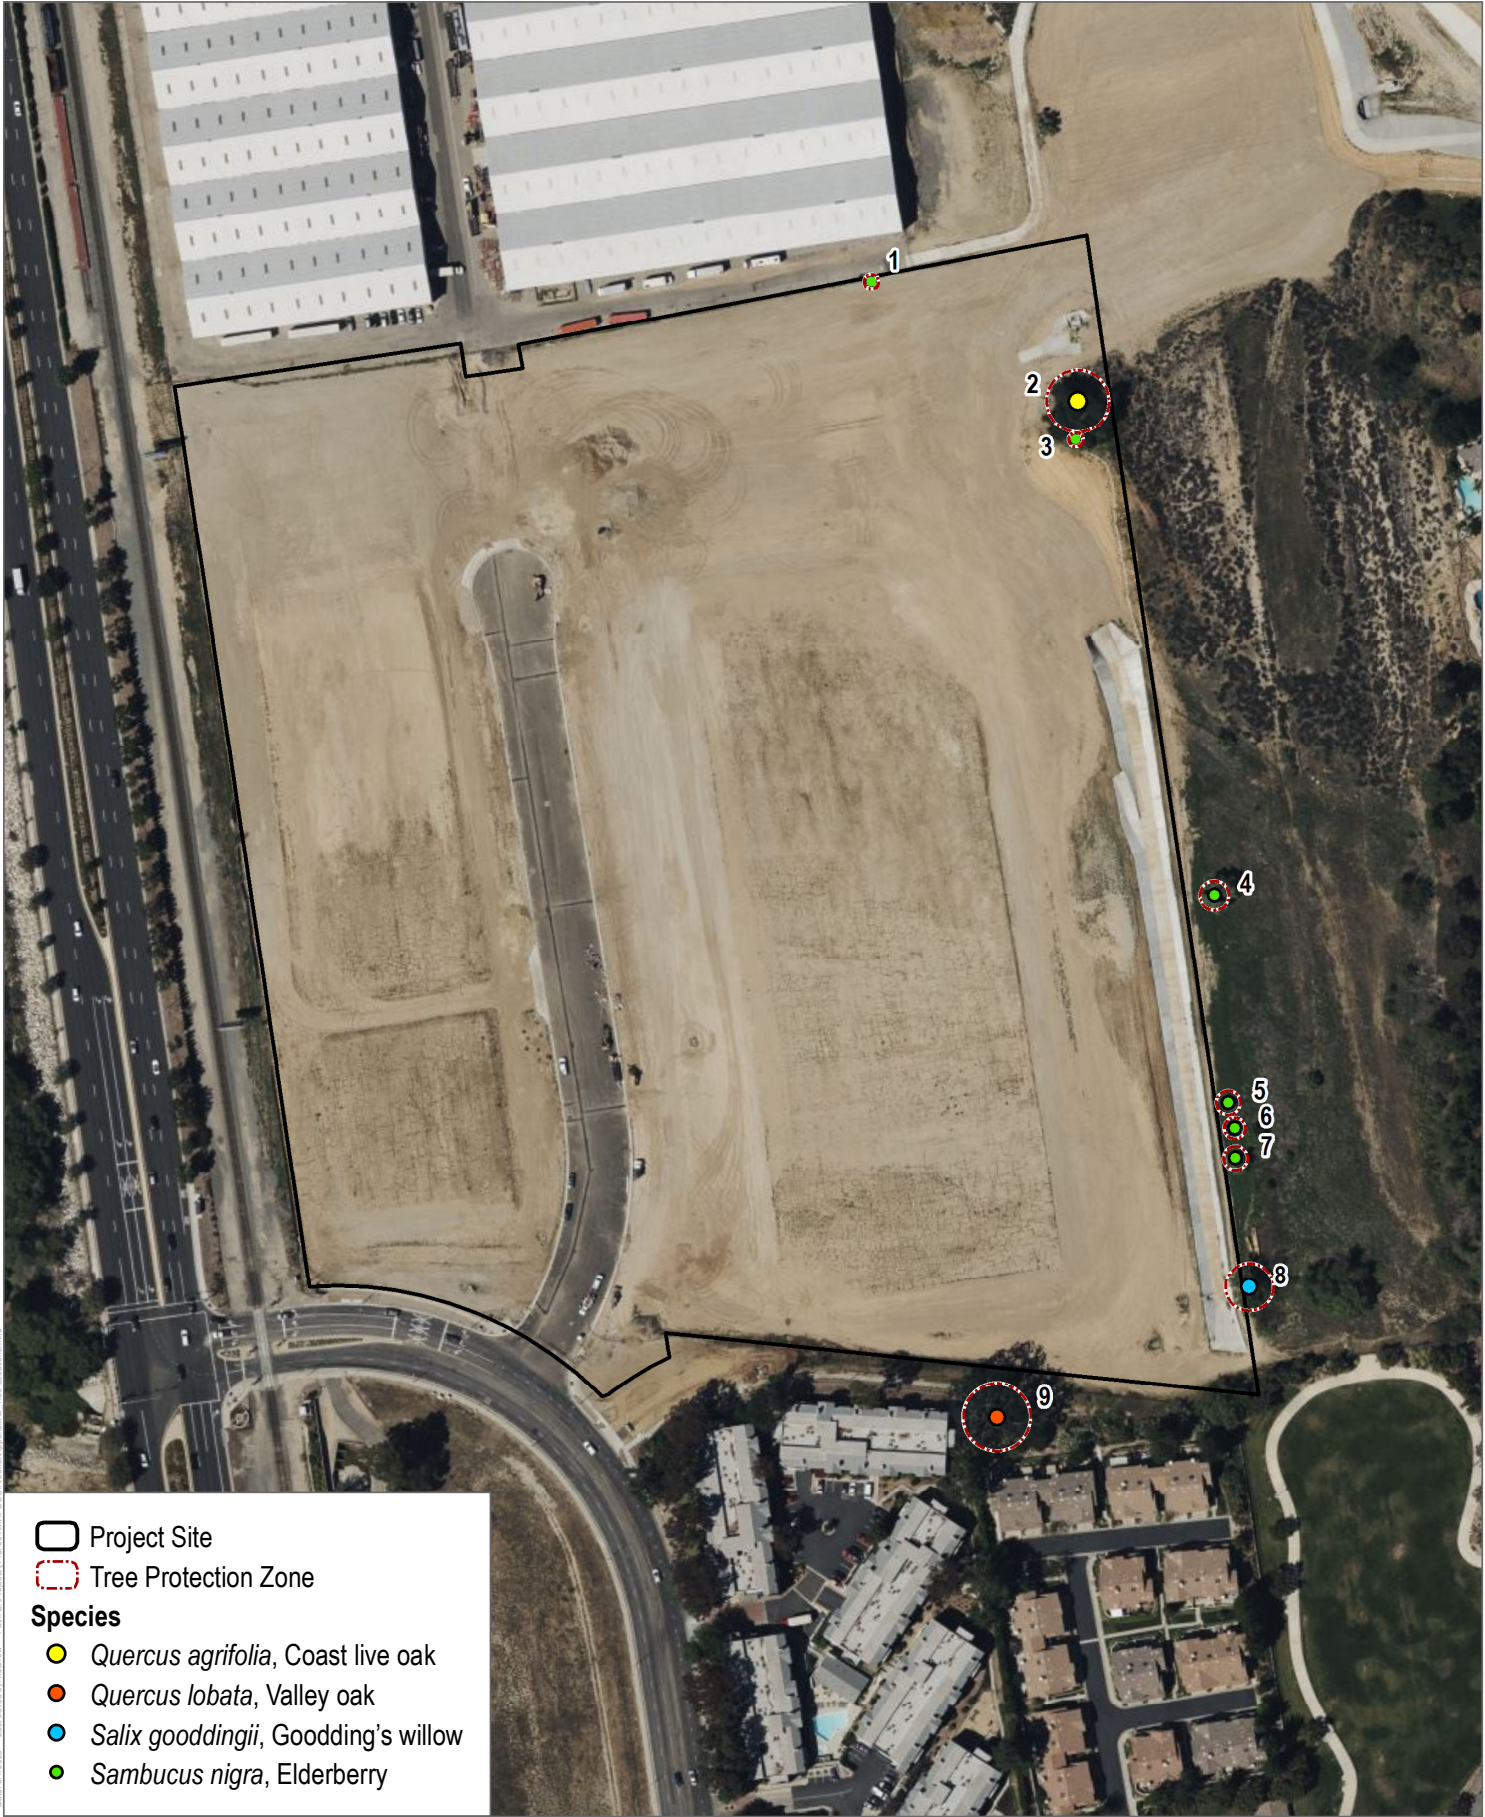
Tree Location and Protection Exhibit

Project Site
 Tree Protection Zone

In total, six non-protected trees and two protected oak trees located on and adjacent to the project site are recommended for preservation. Tree protection is a key component in the continued success of the trees on the site, especially those immediately adjacent (encroachment trees) to the project footprint. As such, and in an effort to enhance the survivability of those trees designated for retention adjacent to the project site and to minimize project-related impacts, Dudek recommends tree protection through implementation of the Tree Protection Measures provided in Attachment D. Furthermore, Dudek recommends that all work occurring within the tree protection zone of the retained trees be monitored by a qualified ISA-certified arborist to ensure tree protection measures are followed and to assess tree impacts that may lead to tree failure.
