Appendix F.
Hazardous Materials Assessment

MEMORANDUM

To: Peter Vanek, Integral Communities
From: Jamie Schnieders, Audrey Herschberger, Dudek
Subject: Hazardous Materials Assessment for Riverview Development Project
Date: March 6, 2024
Attachments: A – Site Map
B – Historical Aerial Photographs
C – Historical Topographic Maps

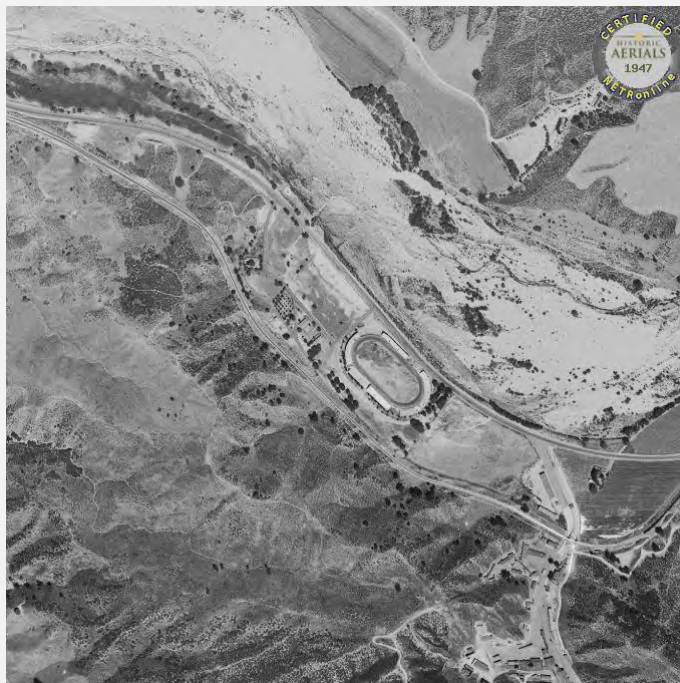
Aerial 1. Aerial photograph of the project site from 1947.

Date	Project Site	Adjoining and Surrounding Areas
1947	The project site appears to have a racetrack in the eastern portion with bleachers surrounding the track. A building is observed in the northeast corner of the project site, surrounded by trees. Two identical buildings are located at the center of the project site with an auxiliary structure and a small orchard to the west. At the base of the hill in the western portion of the project site, another building is observed surrounded by several trees. In the western portion of the project site, a trail extends up the hill to a square structure at the hill’s peak.	The areas surrounding the subject property to the north, west, and south appear undeveloped. The lot adjoining the project site to the east is cleared, with two rectangular buildings to the southeast. Several buildings and other structures appear to the southeast of the project site. The Santa Clara River is observed to the north of the project site on the other side of present-day Soledad Canyon Road. A rail line borders the southern boundary of the project site.

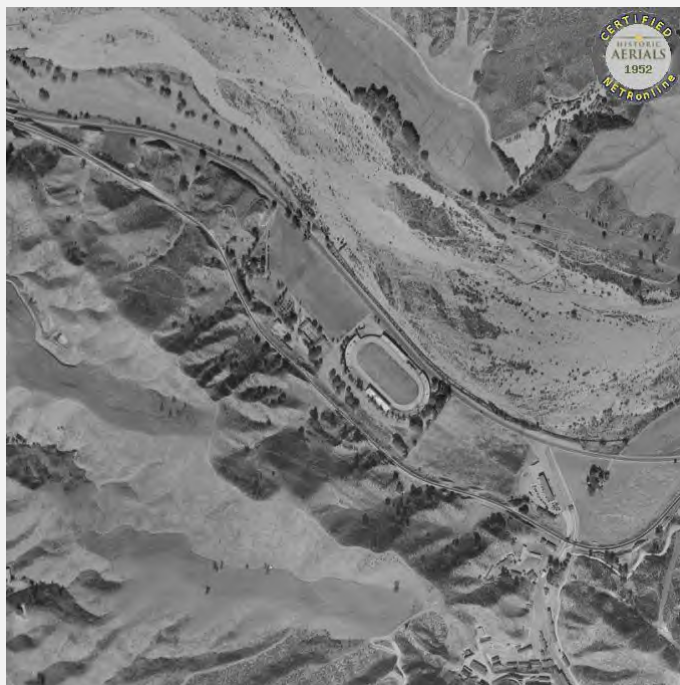
Aerial 2. Aerial photograph of the project site from 1952.

1952	The project site appears similar to the 1947 aerial photograph.	The adjoining and surrounding properties appear similar to the 1947 aerial photographs.
1959	The majority of the project site appears similar to the 1952 aerial photograph. The orchard to the west of the buildings in the center of the project site is no longer observed.	The adjoining properties appear similar to the 1952 aerial photographs. Development (land grading) is observed across the Santa Clara River to the north of the project site.
1969	The racetrack now appears to have added routes crisscrossing through the center in a figure eight. The bleachers for the eastern segment of the racetrack appear to have been	A new structure is observed in the previously vacant lot adjoining the project site to the southeast. Light-use dirt roads appear to lead to a water tower in the hills to the south of the project site.

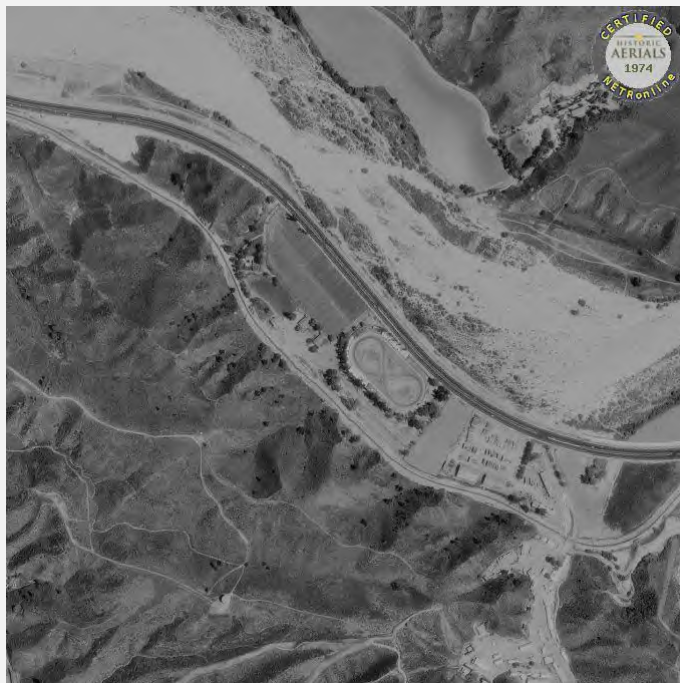
Aerial 5. Aerial photograph of the project site from 1974.

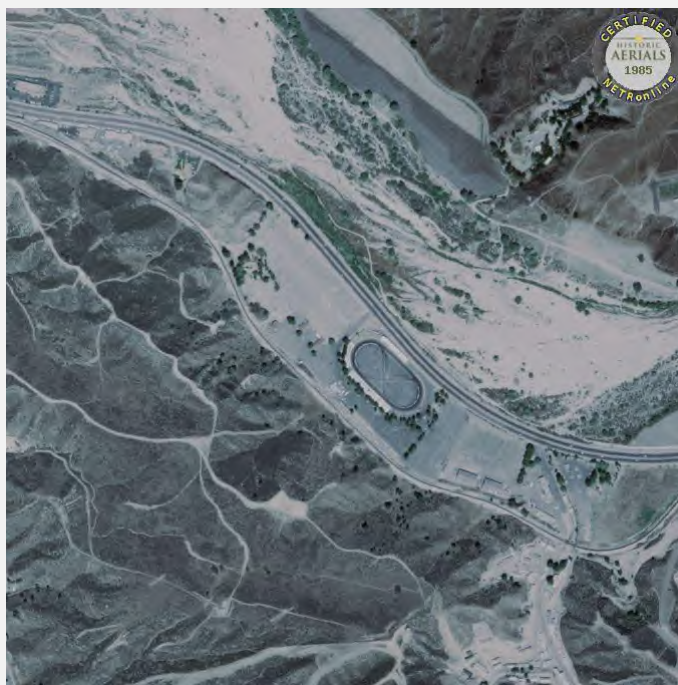
Aerial 7. Aerial photograph of the project site from 1985.

1985	Several trees appear to have been removed from around the racetrack to the north. The rest of the project site appears similar to the 1977 aerial photograph.	A large clearing is observed in the hills south of the project site, to the north of the water tower. Two more commercial buildings are observed west of the project site on Soledad Canyon Road. Some grading is observed northeast of the project site, east of the development north of the Santa Clara River.
1992	The building in the western portion of the project site is no longer observed. The trail in the western portion of the project site appears to be overgrown.	The eastern-most building in the southeastern adjoining lot appears to be under construction. A space to the west of the development north of the Santa Clara River has been cleared of vegetation.
1996	One of the two buildings in the center of the project site appears to have been demolished. Half of the vacant lot to the north of the center buildings appears paved. The figure eight in the center of the racetrack appears to have faded.	A wide, unpaved road leading to a small white structure is observed in the hills to the south of the project site. The water tower is no longer observed in the hills. Additional grading is observed north of the Santa Clara River. The lot adjoining the project site to the southeast is now observed to be a parking lot with a paved road along its borders.

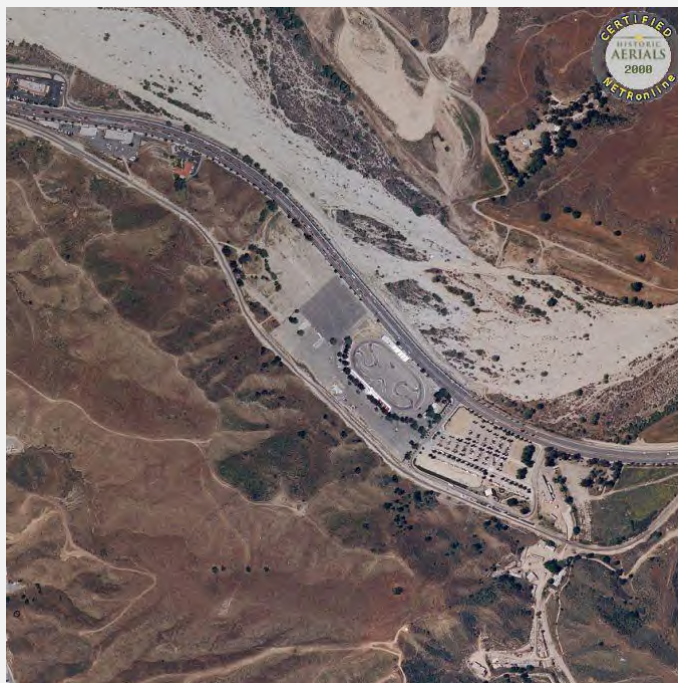
Aerial 10. Aerial photograph of the project site from 2000.

2000	The remaining building at the center of the project site is no longer observed. A new route within the racetrack is observed.	A dirt road is observed parallel to the Santa Clara River to the north, connecting the cleared grading area and the other developed lot and extending east. A white building is observed in the southern portion of the lot adjoining the project site to the southeast.
2005	The racetrack is now observed in the original oval shape. One building in the center of the project site is observed on the footprint of the previously demolished building.	The adjoining and surrounding properties appear similar to the 2000 aerial photograph.

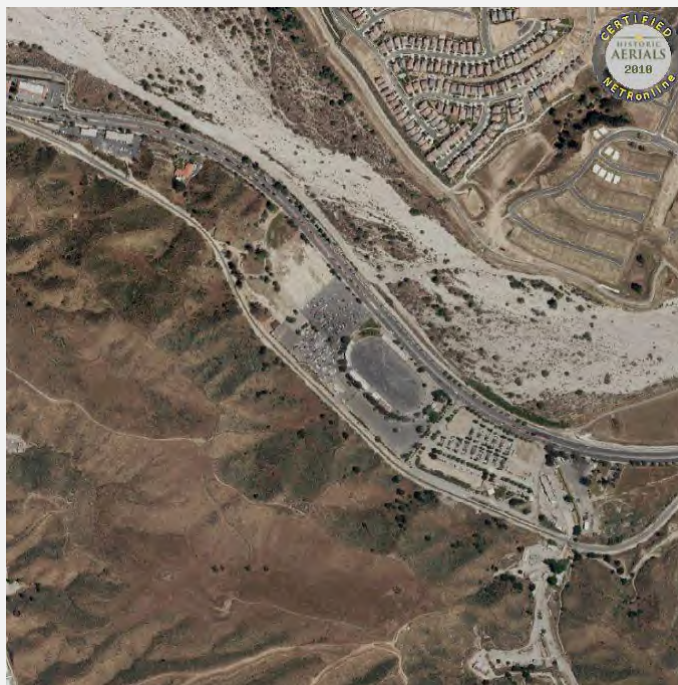
Aerial 12. Aerial photograph of the project site from 2010.

Date	Project Site	Adjoining and Surrounding Areas
2010	The project site appears similar to the 2005 aerial photograph.	The development north of the Santa Clara River appears to have been cleared. Directly west of it, residential track homes are observed with paved roads throughout the community. Pre-construction and paved roads are observed to the east of the new community.
2014	The paved parking area appears to have been extended to the west on the project site. The remaining areas of the project site appear similar to the 2010 aerial photograph.	An area to the southeast of the project site appears to be cleared of vegetation and graded for more residential units. More track homes appear to have been built in the graded areas north of the Santa Clarita River.
2018	Many vehicles and canopies are spaced out throughout the project site. The image was likely taken during the Santa Clarita Swap Meet. The features of the project site appear similar to the 2014 aerial photograph.	A park with walking paths is observed between the two residential communities north of the Santa Clara River. Homes are now observed within the graded area to the east of the project site. A bridge crosses Soledad Canyon Road from the homes east of the project site.

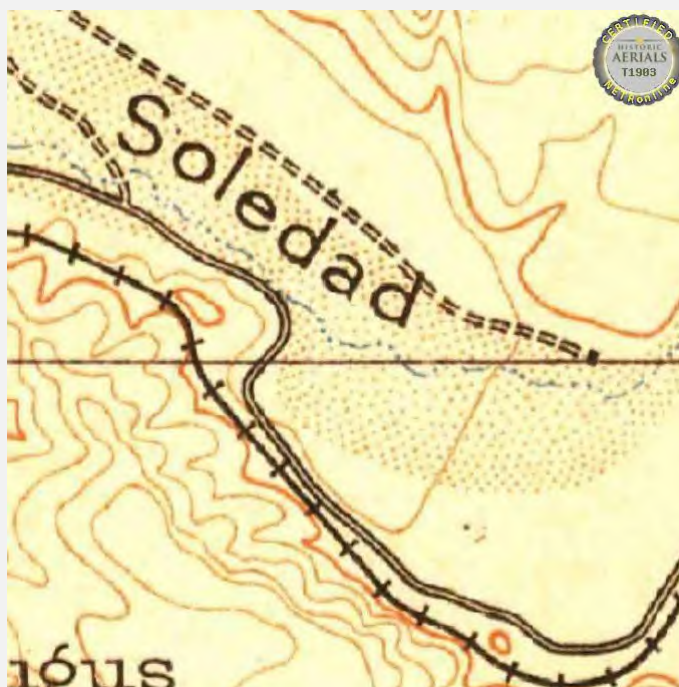
Topographic Map 1. Topographic map of the project site in 1903.

Date	Project Site	Adjoining and Surrounding Properties
1903	The project site is depicted on the floodplain of an intermittent river. The river flows southeast to northwest along the northeastern portion of the project site. A road runs along the southern border of the project site, parallel to a single-track railroad.	A dirt road is observed on the north side of the intermittent river. The road comes from northwest of the project site and terminates approximately 500 feet northeast of the project site. South of the project site, elevation increases indicate the presence of hills.
1908	The project site is similar to its appearance on the 1905 topographic map.	The adjoining and surrounding properties are similar to their appearance on the 1905 topographic map.

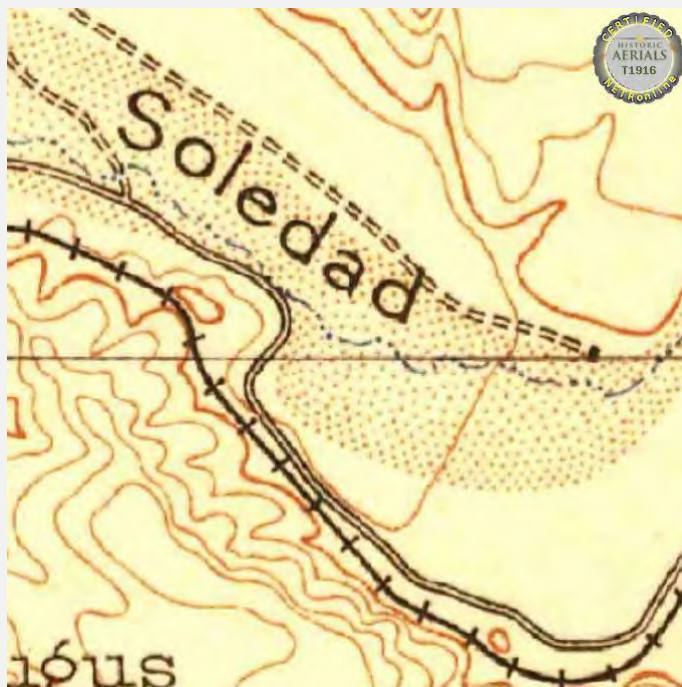
Topographic Map 3. Topographic map of the project site in 1916.

Date	Project Site	Adjoining and Surrounding Properties
1916	The project site is similar to its appearance on the 1908 topographic map.	The adjoining and surrounding properties are similar to their appearance on the 1908 topographic map.
1924	The project site is similar to its appearance on the 1916 topographic map.	The adjoining and surrounding properties are similar to their appearance on the 1916 topographic map.
1929	A racetrack and bleachers are depicted on the project site. A dirt road is depicted through the center of the project site from east to west. The dirt road circles in front of a building and exits the project site onto another road, which bounds the project site to the northeast. Two buildings are depicted along the dirt road in the eastern portion of the project site.	The dirt road to the north of the project site, across the intermittent river, is no longer depicted on the map. The railroad adjoining the project site to the south is labeled as "Southern Pacific." The area north of the project site is labeled "Baker Ranch." A depression is depicted to the west of the project site and across the railroad to the south of the project site. A dirt road is depicted east of the project site, with two buildings on either side. The road running parallel to the railroad is no longer depicted on the map. Two intermittent drainages appear in the hills south of the project site.

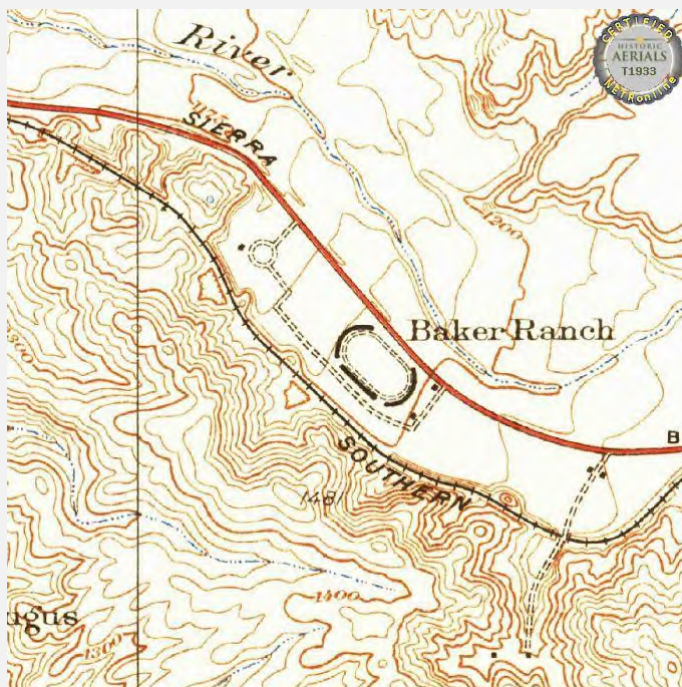
Topographic Map 6. Topographic map of the project site in 1933.

1933	A water body is depicted on the hill in the western portion of the project site. The remaining areas of the project site appear similar to the 1929 topographic map.	The road bordering the northeastern portion of the project site appears to be depicted as Sierra Highway. Two buildings are observed at the end of the dirt road to the east of the project site.
1939	The project site appears similar to its appearance in the 1933 topographic map.	The adjoining and surrounding properties are similar to their appearance on the 1933 topographic map.
1943	The project site is similar to the 1939 topographic map, although less features are represented.	Baker Ranch is now depicted as Bonelli Ranch. The dirt road north of the Santa Clara River is again depicted with six buildings at the terminus. A second road is depicted from the Sierra Highway toward the two buildings at the end of the dirt road east of the project site. The area south of the project site is labeled as Saugus.

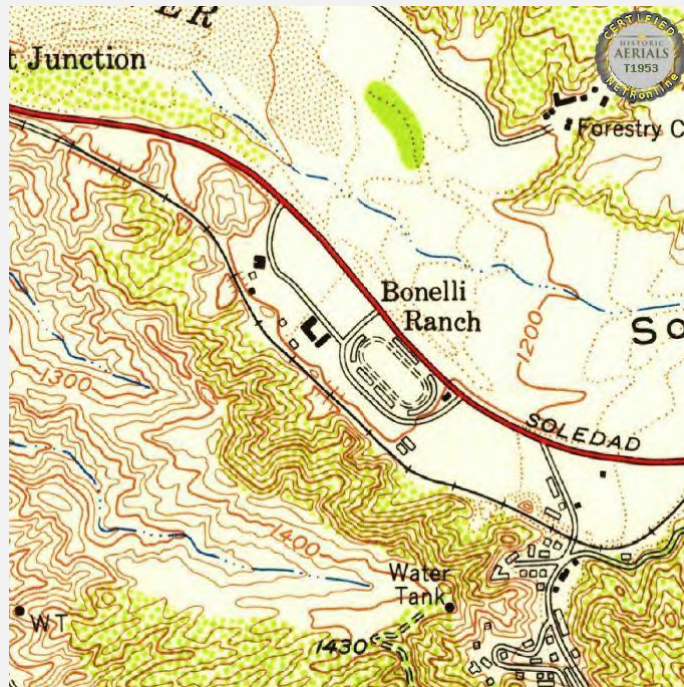
Topographic Map 9. Topographic map of the project site in 1953.

1953	Seven new buildings are observed on the project site. The previously dirt road is again depicted without the circle in front of the building in the western portion of the project site. The water body on the hill in the west of the project site no longer depicted.	Two water tanks are depicted in the hills south of the project site. Many buildings are depicted in the area southeast of the project site. Shrubland is depicted south and north of the project site. Eight buildings are depicted north of the Santa Clara River and are identified as a Forestry Camp.
1958	The project site is similar to its appearance on the 1953 topographic map.	The adjoining and surrounding properties are similar to their appearance on the 1953 topographic map.
1970	The project site is similar to its appearance on the 1958 topographic map.	A large building is depicted in the southeastern adjoining lot to the project site. A tank is depicted in the hills south of the project site, west of the previously noted water tank.

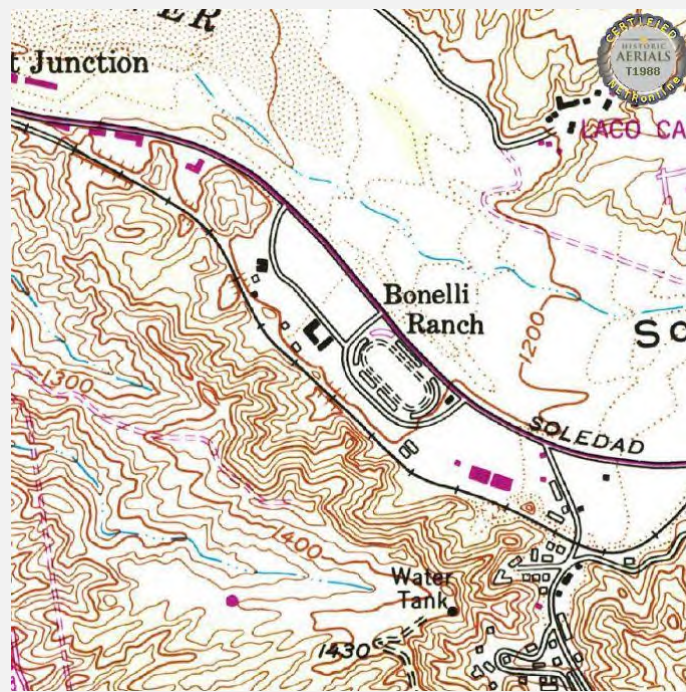
Topographic Map 12. Topographic map of the project site in 1988.

1988	More bleachers are depicted in the northwestern corner of the racetrack. The remaining area of the project site appears similar to the 1970 topographic map.	Five more buildings are depicted in the southeastern adjoining lot. Several dirt roads are depicted in the hills south of the project site. One L-shaped building is depicted on the lot west-adjacent to the project site. Five buildings are depicted west of the project site, along Soledad Canyon Road. The Forestry Camp is now depicted as LACO Camp and has three more buildings. A dirt road extends east from LACO Camp.

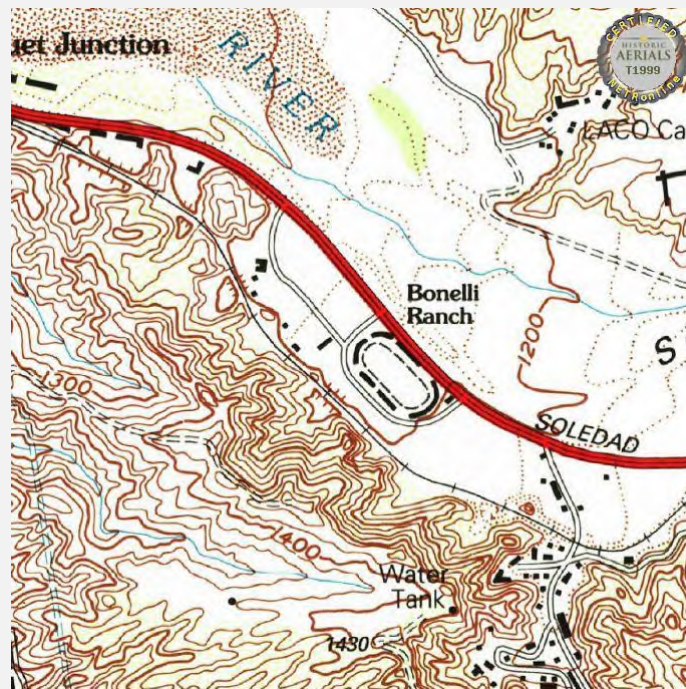
Topographic Map 13. Topographic map of the project site in 1999.

Date	Project Site	Adjoining and Surrounding Properties
1999	Three buildings are no longer depicted on the project site: two in the southeast corner and one in the center of the project site.	One, large cross-shaped building is depicted to the northeast of the project site, across the Santa Clara River. The remaining adjoining and surrounding properties appear similar to the 1988 topographic map.
2012	The project site appears to be identified as Saugus Speedway, next to Bonelli Ranch. All structures previously depicted are no longer observed on the project site.	Bonelli Ranch is depicted southwest of the project site. The road to the southeast is now labeled as a Commuter Way. Many new roads are depicted surrounding Los Angeles County Camp 10, formerly labeled LACO Camp, north of the Santa Clara River.
2015	The project site appears similar to the 2012 topographic map, apart from the Saugus Speedway label.	Commuter Way, southeast of the project site, no longer extends south into the hills but is horseshoe-shaped with both ends connecting with Soledad Canyon Road. Floodplain sand deposits are depicted northwest of the project site, north adjacent to the Santa Clara River.

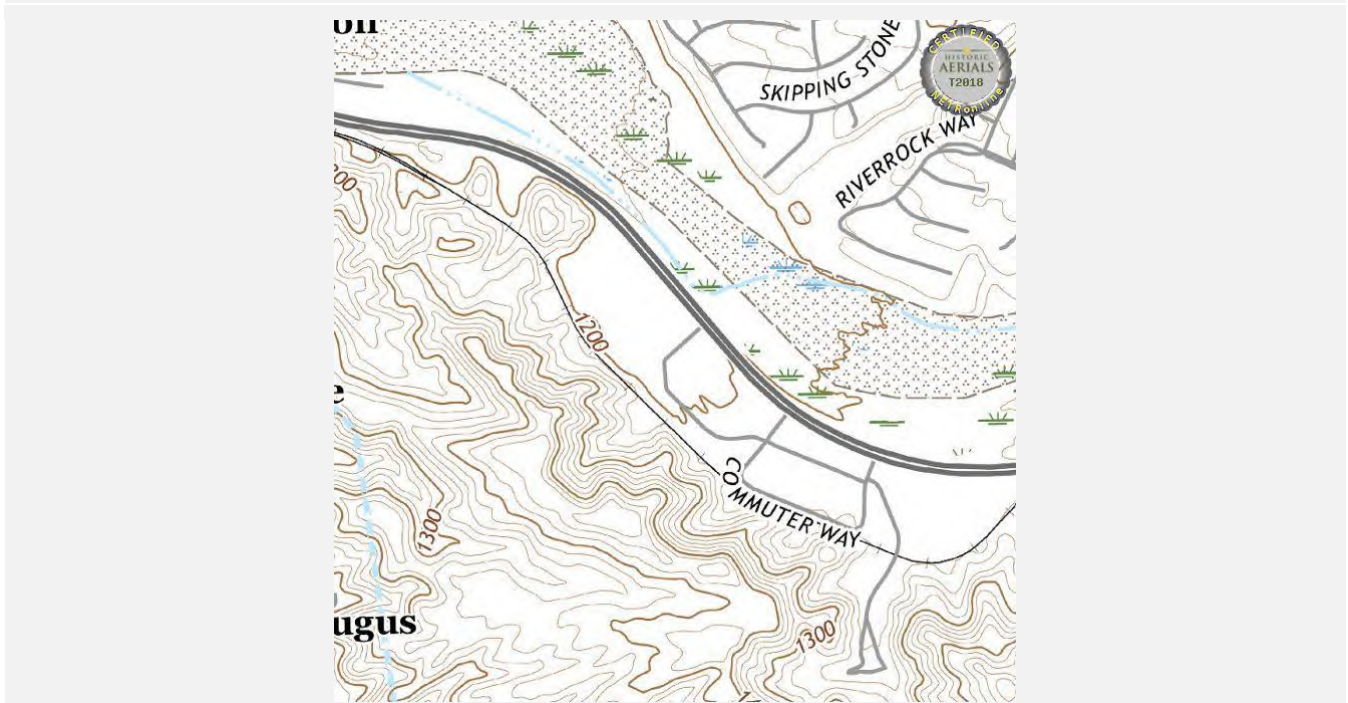
Topographic Map 16. Topographic map of the project site in 2018.

2018	A road extends into the project site from the east and curves to the northeast to connect back to Soledad Canyon Road.	The road in the project site originates from crossing through Commuter Way to the southeast of the project site. The Santa Clara River floodplain is mapped to the north of the project site with marshes flanking both sides of the valley.
